## Implementation report

# Protection of *Luronium natans*, Breisjøen 2019/2020/2021

## Innvilget tilskudd til kartlegging og overvåking av flytegro i Breisjøen 2021 - Roman Gramsz. Ref. 21SE14E9

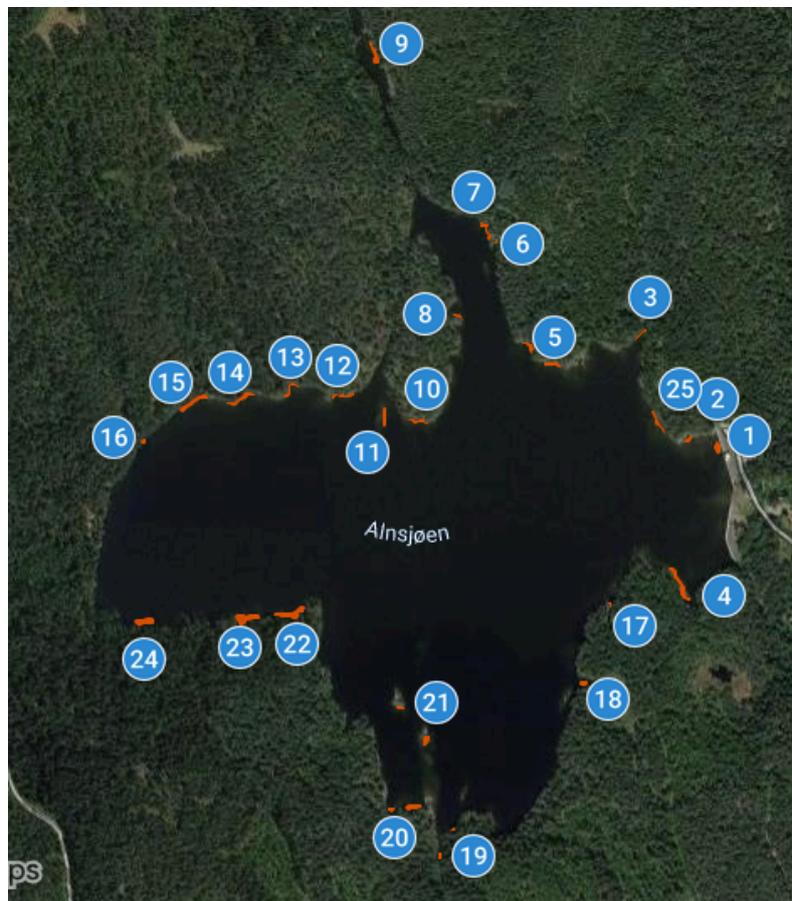
In 2019, about 5,000 *Luronium natans* plants were transplanted from Breisjøen to 25 sites in Alunsjøen (Map 1.)

Map 1. Planting places in Alunsjøen along with the numbering of these stands. Planting places are marked in red.

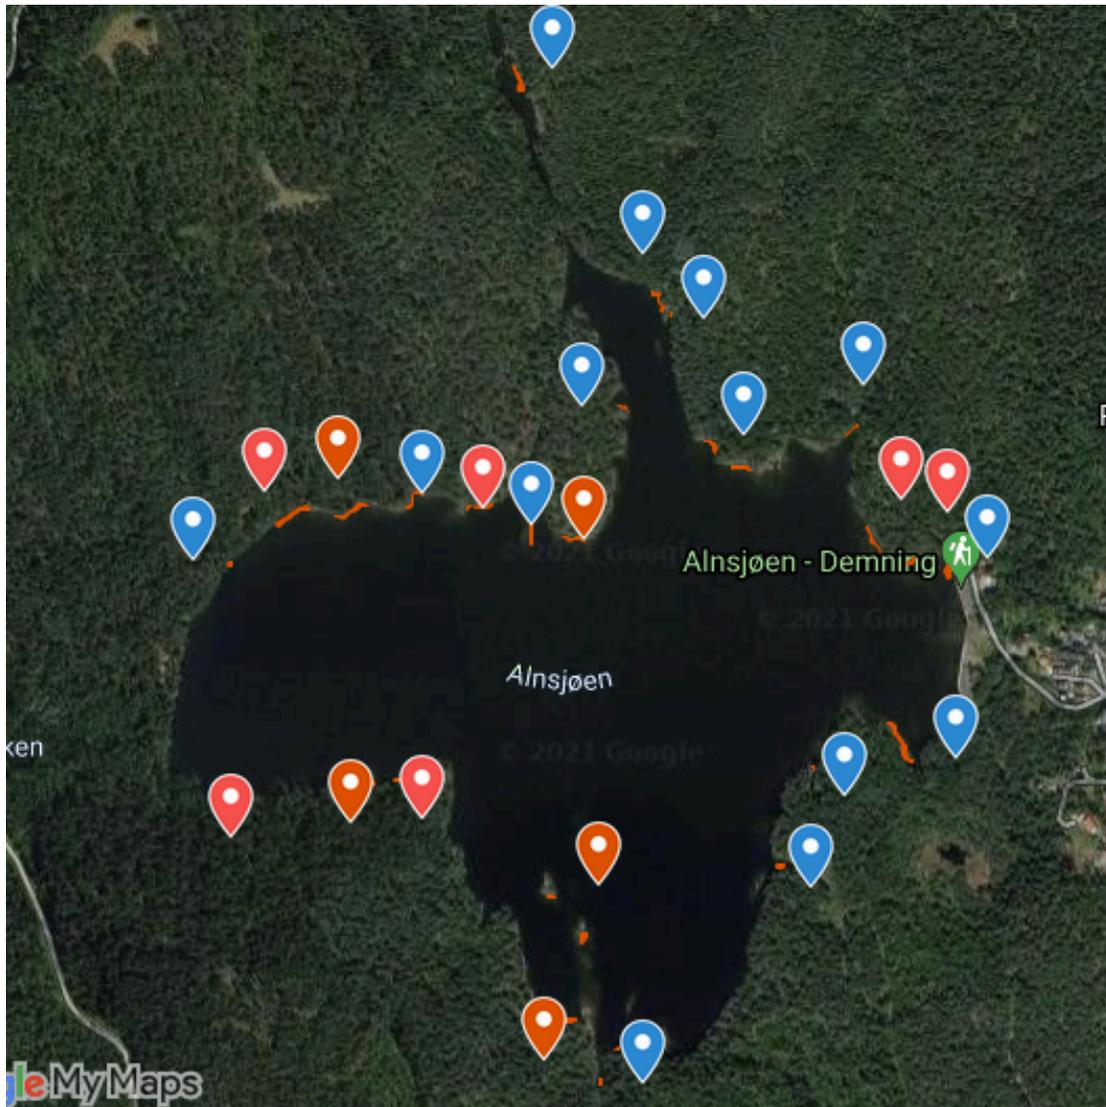
Live plants were found in 11 places out of 25 where they were planted in 2019.

At these sites, from a few to a dozen plants were found, which gave a total of about 100 plants that were adopted in Alunsjøen.

Map 2. Result of transplanting *Luronium* to Alunsjøen. As of July 28, 2021. The 2019 planting locations (areas) are marked in red. Places where the presence of *Luronium* has been confirmed in 2021 - red points. Blue points - not confirmed.

On the map 2. all the planting sites and the sites where the plants have adopted are marked.

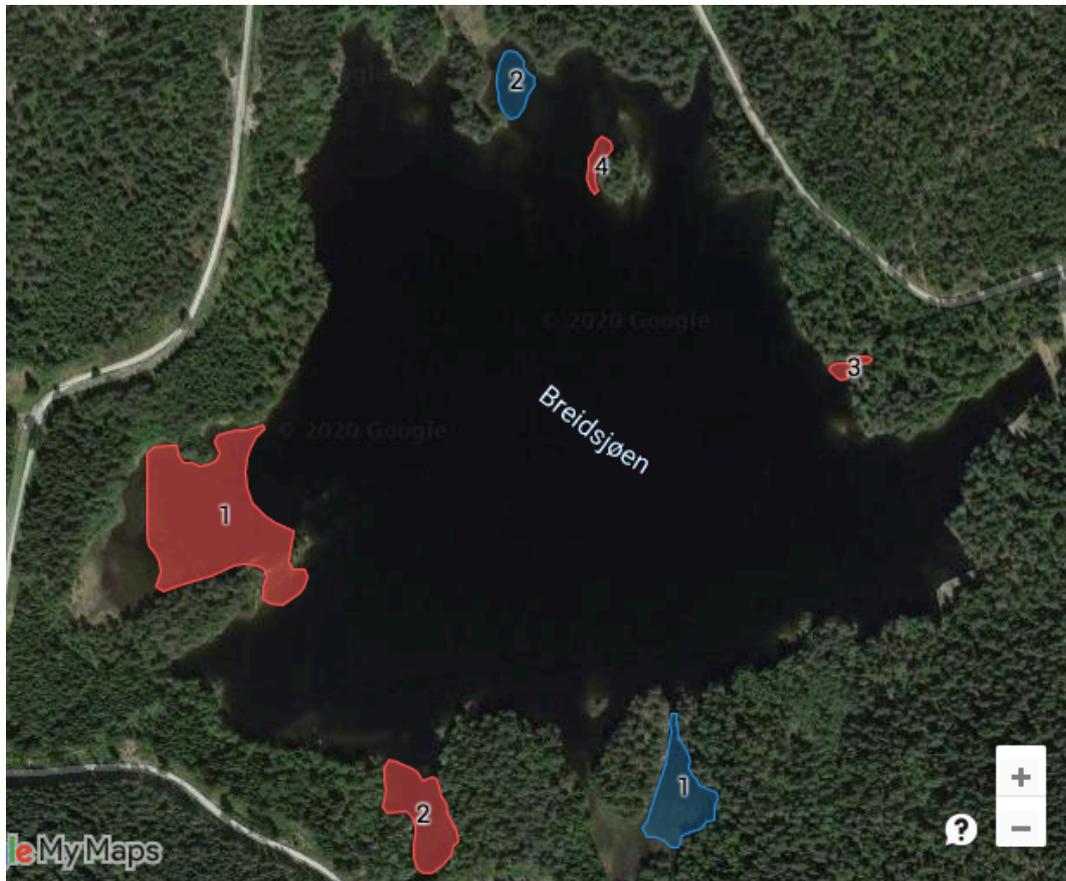
Map 3. Preliminary map of the distribution of areas intended for irrigation (red) and for flooding, construction of small dams (blue).

This project has been approved for implementation with the exception of area no 2 (red). The project aimed to protect the flytegro in different ways in different depth zones and habitats.

At the beginning of April 2020, Vav started draining Breidsjøen. During the first working meeting with representatives of Vav and Consto (contractor) on April 22, 2020, the water level in Breidsjøen was already 2m lower and most of the *Luronium natans* - flytegro were visible on the dry shore. After a local inspection of the lake, I was asked to make a map with the marking of individual places and ways to protect the flytegro. (see Map 3.)

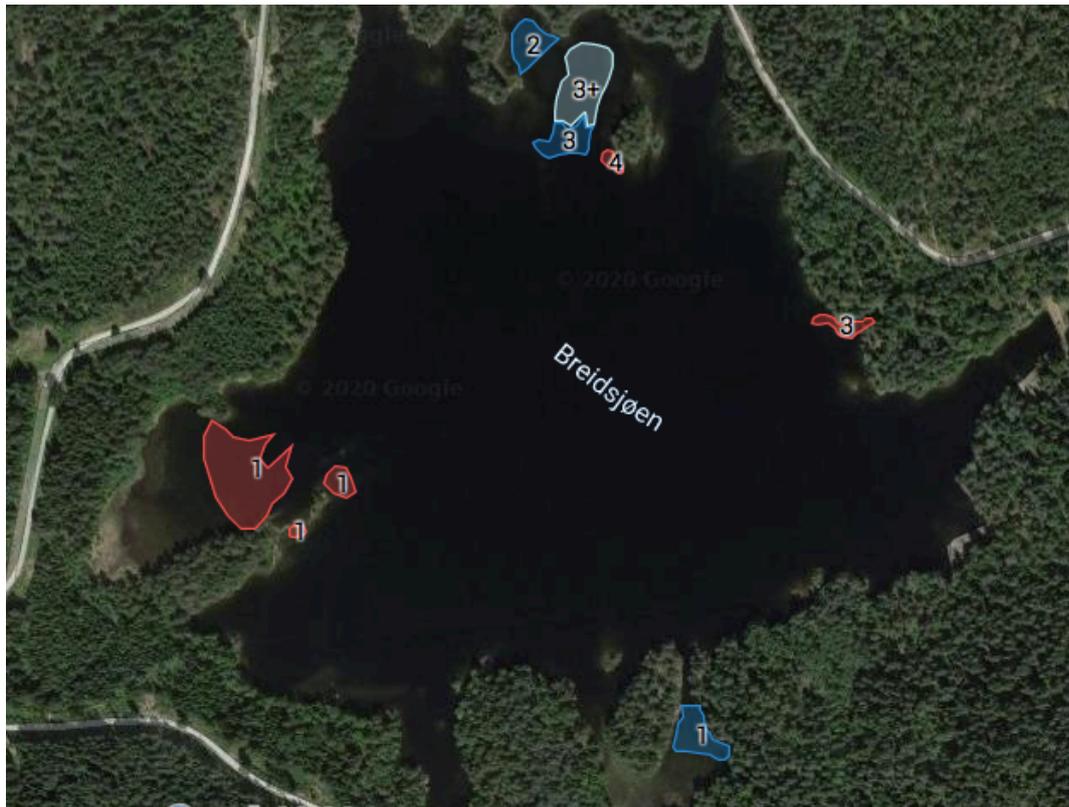
Map 4. Completed layout of irrigation areas and dams after border correction and construction of "our dam" no 3.

The following irrigation systems and dams were built: (see Map 4.)

Work on the construction of the dams and the installation of irrigation systems began immediately, but it took over a month to bring them to proper functioning. (Pumps were not immediately placed at the appropriate depth and, as the water level continued to decline, they became clogged with silt or remained on the dry shore)

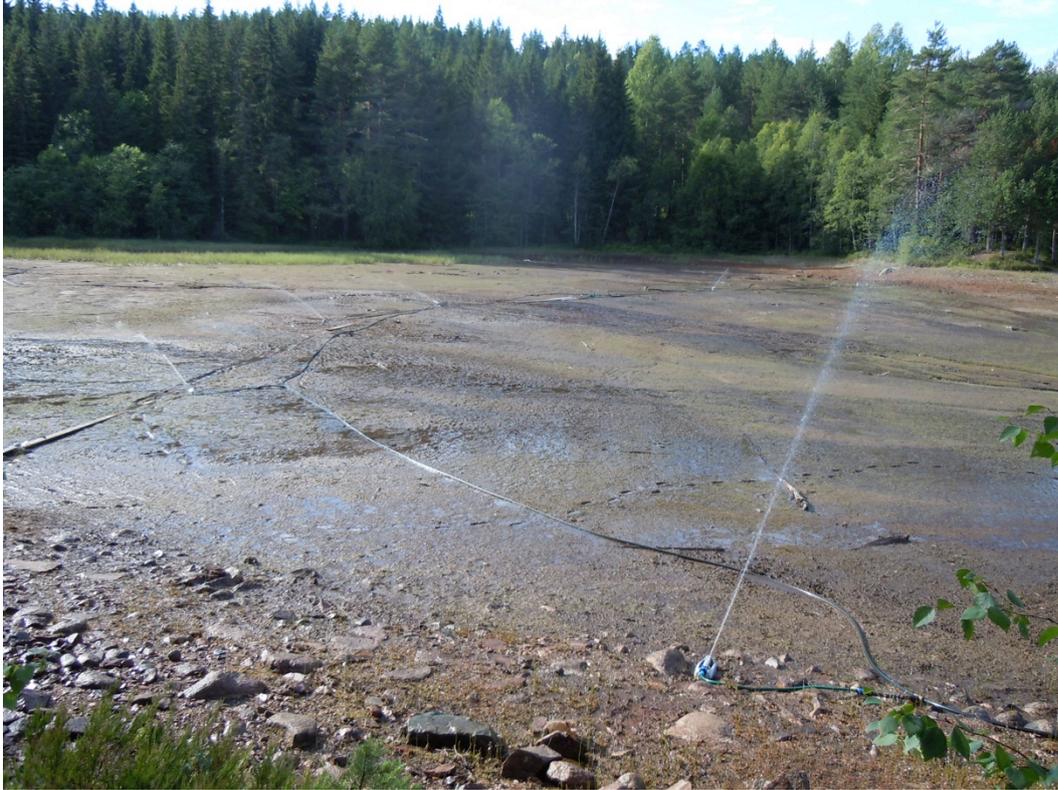
1. No 1 (red) Irrigation of the bay and peninsula in the Western part of the lake. This vast bay with a slightly sloping, silty bottom and abundant flytegro occurrence could ensure the survival of the plants if it could be kept wet or at least moist. An irrigation system was installed across the bay so that the sprinkled was a 20m wide strip and excess water flowed down below, moistening the rest of the exposed bay bottom. In this boggy bay, plank footbridges had to be built to provide access to the sprinklers. 3 sprinklers were placed higher on the peninsula to support plants in other habitats (at a depth of about 50 cm and 2 m from the normal water level) This system worked well - it allowed most of the plants on the irrigated surface to survive and grow as a terrestrial form. Some plants have been destroyed or damaged by grazing of the Canadian goose family and ducks. The system was dismantled on 10/21/2020 when most of the plants were already under water again. Detailed observations of the diving method carried out in the summer of 2021 confirm that *Luronium* has survived well, especially in the NW part of the bay. In the SW part, they survived a bit worse, probably due to the strong, competitive development of *Juncus bulbosus*. Watering the plants on the shallower bottom of the peninsula saved fewer plants than in the bay, but without this watering, most or all of the plants would probably have died. (Compare on maps from 2018 and 2021.)

Photo 1. No 1 (red) Irrigation on the western bay. 16.07.2020.

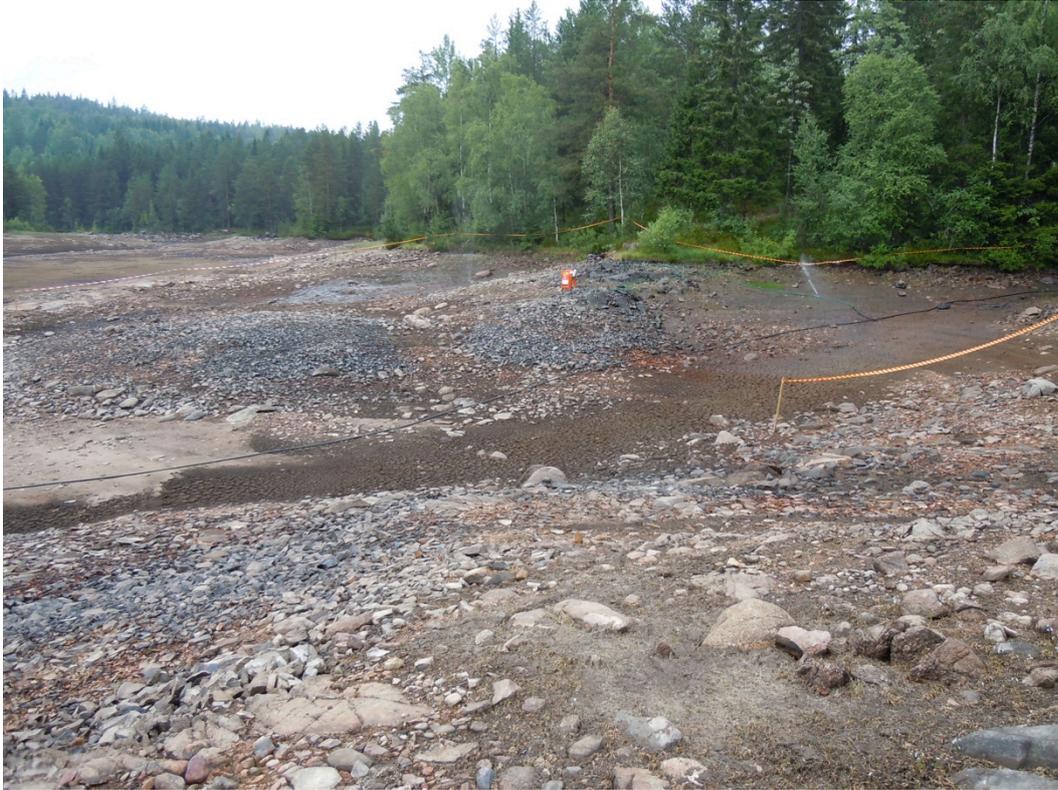
2. No 3 (red) Irrigation of the small bay and the slope of the bottom in the eastern part of the lake.

Plants growing on the bottom slope with a small layer of clay and silt at a depth of 30 cm to 1.5 m were to be protected here. There are 3 sprinklers here.

This system worked well - it allowed most of the plants on the irrigated surface to survive and grow as a terrestrial form.

Observations from 2021 confirmed the survival of many plants, especially in bottom depressions with more clay and silt. In the remaining places where the clay and silt were washed away, the plants survived in smaller numbers.

Photo 2. No 3 (red) Irrigation of the small bay and the slope of the bottom in the eastern part of the lake. 28.06.2020.

At this place, it was necessary to make the tape fence due to the frequent visits of people and the trampling of the plants.

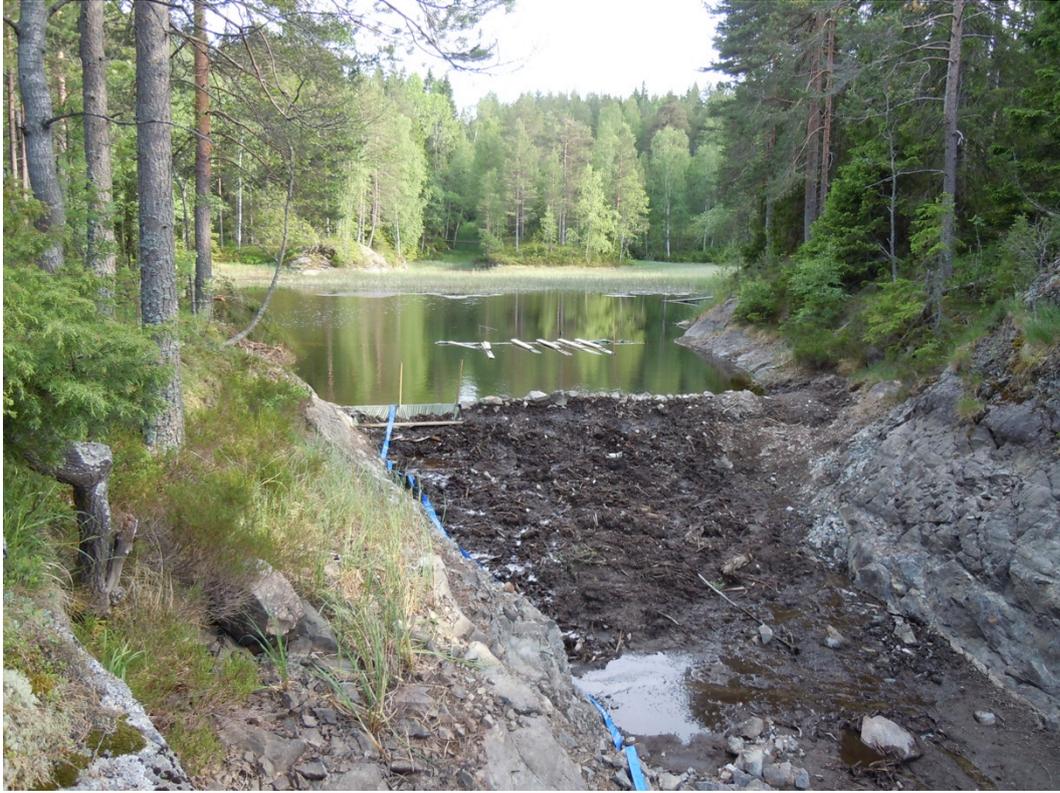
4. No 1 (blue) Dam in the southern part of the lake.

This dam was supposed to keep the plants shallow (20 -30 cm deep) what should enable their survival and cause a strong development of floating leaves and flowers.

This dam did not have the expected effect. A thick layer of organic sediments flowed to the surface of the water and the plants growing there died (?)

Only the plants on the shores of the pond survived. (Compare on maps from 2018 and 2021.)

Photo 3. No 1 (blue) Dam in the southern part of the lake. 11.06.2020.

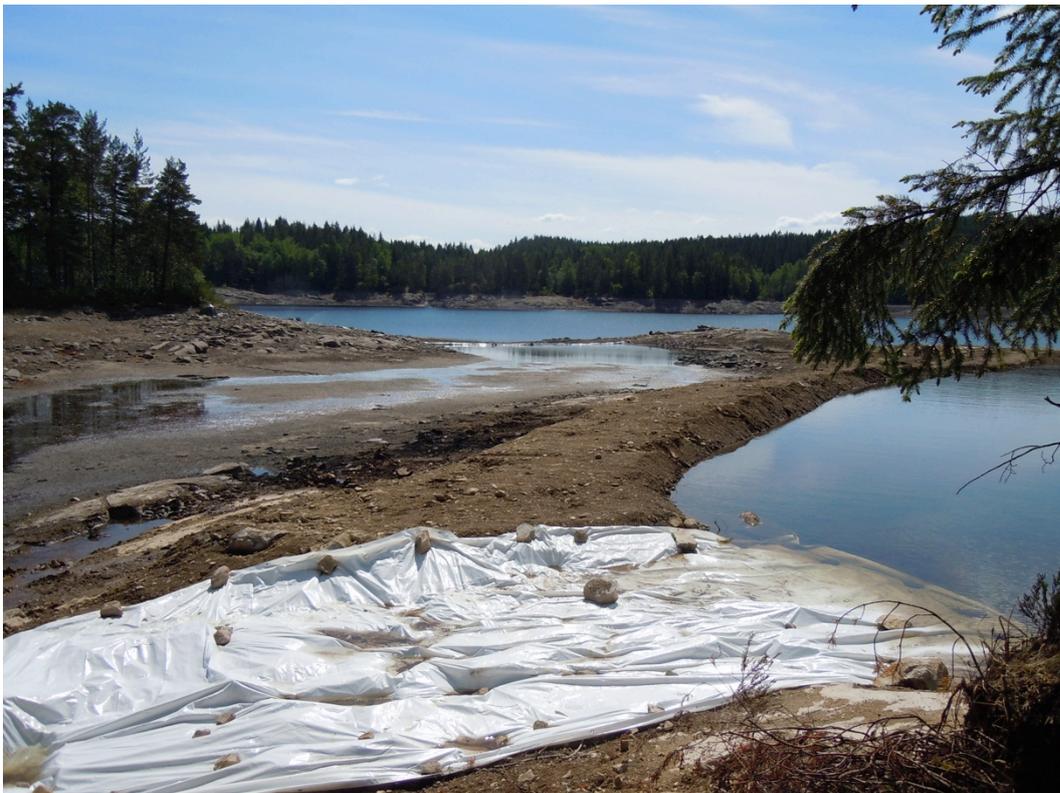
Photo 4. No 2 (blue) Dam (on right), “our dam” no 3 and wet area no 3+ (center), No 4 (red) Irrigation (left) in the northern part of the lake. 11.06.2020.

These dams and irrigation system (no 4) in N Breisjøen has ensured the protection of the flytegro in a variety of habitats and throughout its depth zone. Many means of protection have been used here and it was a great success:

Dam no 2 with a water depth of up to 60 -80 cm enabled the plants to rebuild an underwater, vegetative rosette of leaves. "Our dam" no 3, with a depth of up to 20 -30cm allowed the lush growth of the form with floating leaves and flowers. The deliberately overflowing water from dam no. 2 irrigated the surface of a large flat area (no 3+) of the bottom above "our dam" contributing to a very lush growth of the flytegro terrestrial form. Sprinkling on the slope of the island (no 4 (red)) kept some plant alive in terrestrial form.

Unfortunately, this area suffered from bird feeding. Some damage was done by the Canadian goose family in May and June, but the ducks feeding in autumn at night did a great deal of damage already during the filling of Breisjøen in October. Almost 100% of plants with floating leaves and a large part of the terrestrial form were destroyed.

Observations from 2021 confirm the enormity of damage caused by the autumn feeding of ducks. Virtually the entire area of "our dam" was completely devoid of plants. Fortunately, most of the area irrigated by the "dam 2" overflow with the developed land form of *Luronium* has survived. Also, the plants within "dam 2", despite being persecuted by ducks, have mostly survived.

At the end of May, when the water level was already 5 m below normal and all flytegro occurrences were exposed, we decided together with Bjørn Smevold that it would be worth building one more dam below the dam no.2. It would flood a large flat area of the bottom with abundant flytegro occurrence. With the approval of the Vav administration, we built this dam (no 3) out of plastic sandbags with the help of volunteers from Norsk Botanisk Forening.

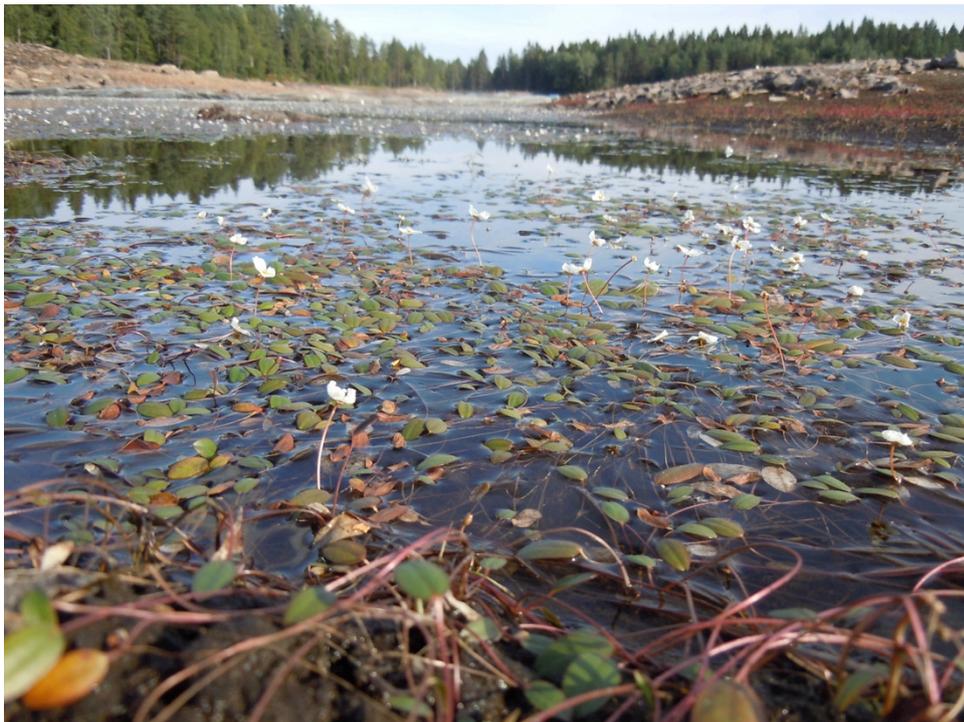
Photo 5. Well developed form with floating leaves and flowers in "our dam"- all this plants have been damaged by ducks in October 2020. 19.08.2020.

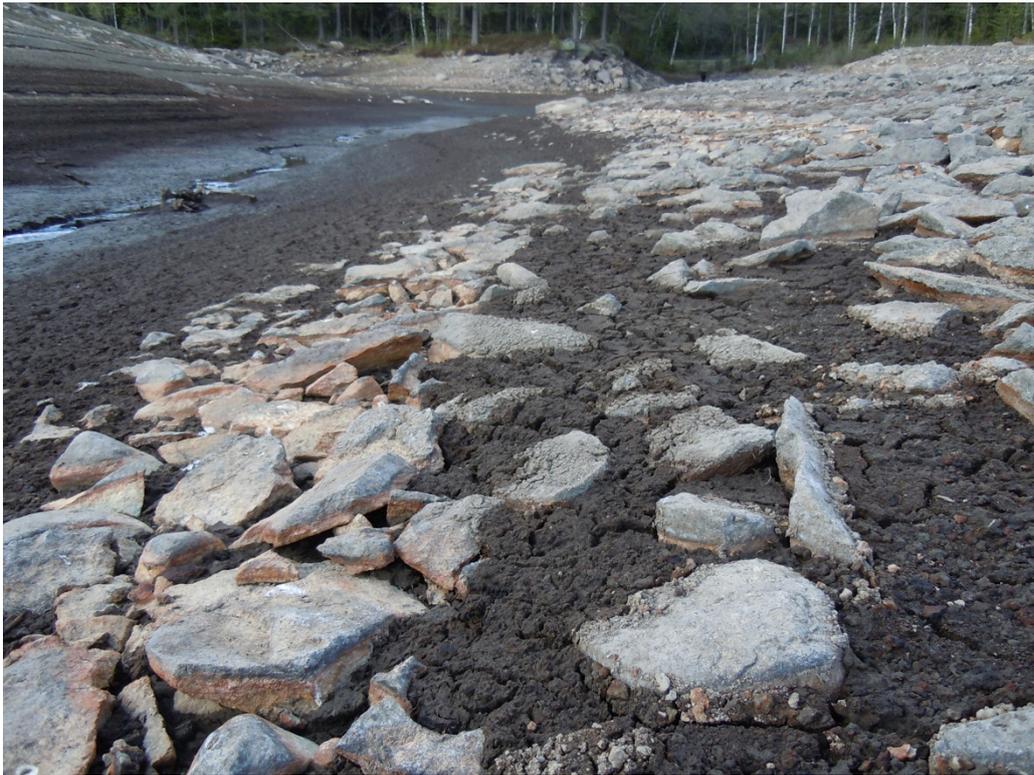
Photo 6. Waves washed away clay and mud from the steep parts of the shore. 19.05.2020.

- 2. Bottom erosion and washing out of sediments were the most destructive factors for the *Luronium*'s habitat. The greatest erosion of the slope of the lake bottom caused waves during the slow lowering of the water level. (this is a topic for discussion with the recommendation to drain water slowly to protect crayfish).**

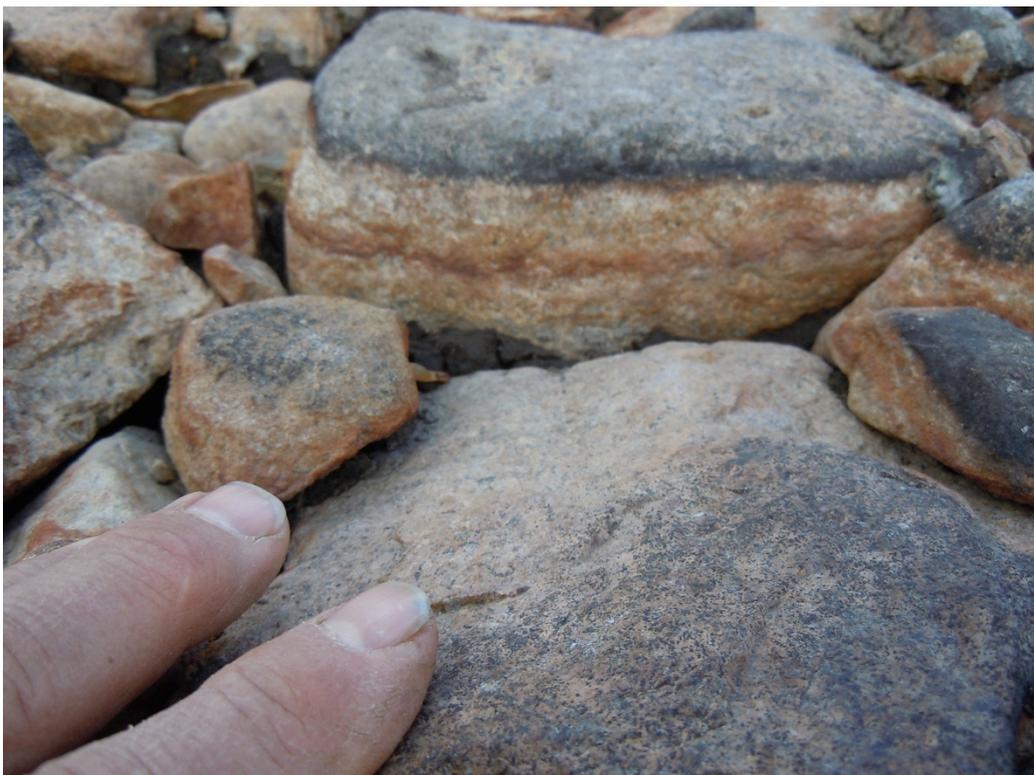
Photo 7. The amount of the washed out sediment is clearly visible on the exposed stones. 19.05.2020

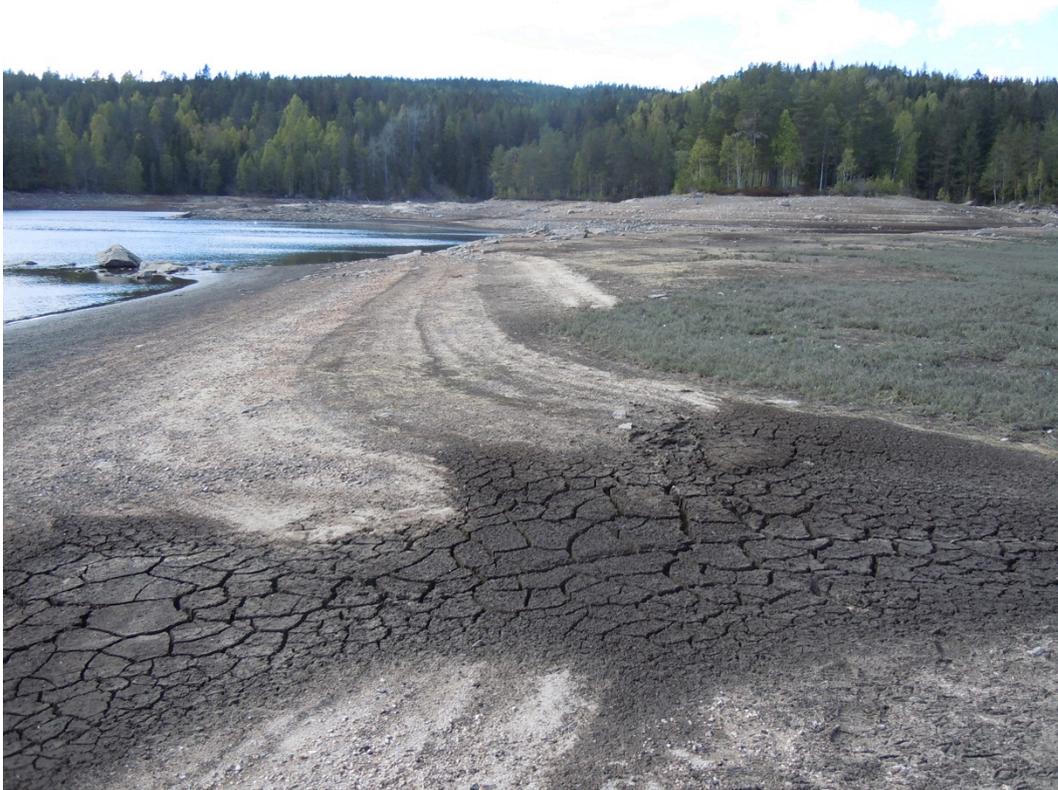
Photo 8. Erosion of the silty-clay layer depending on the intensity of waves during lowering the water level. 19.05.2020.

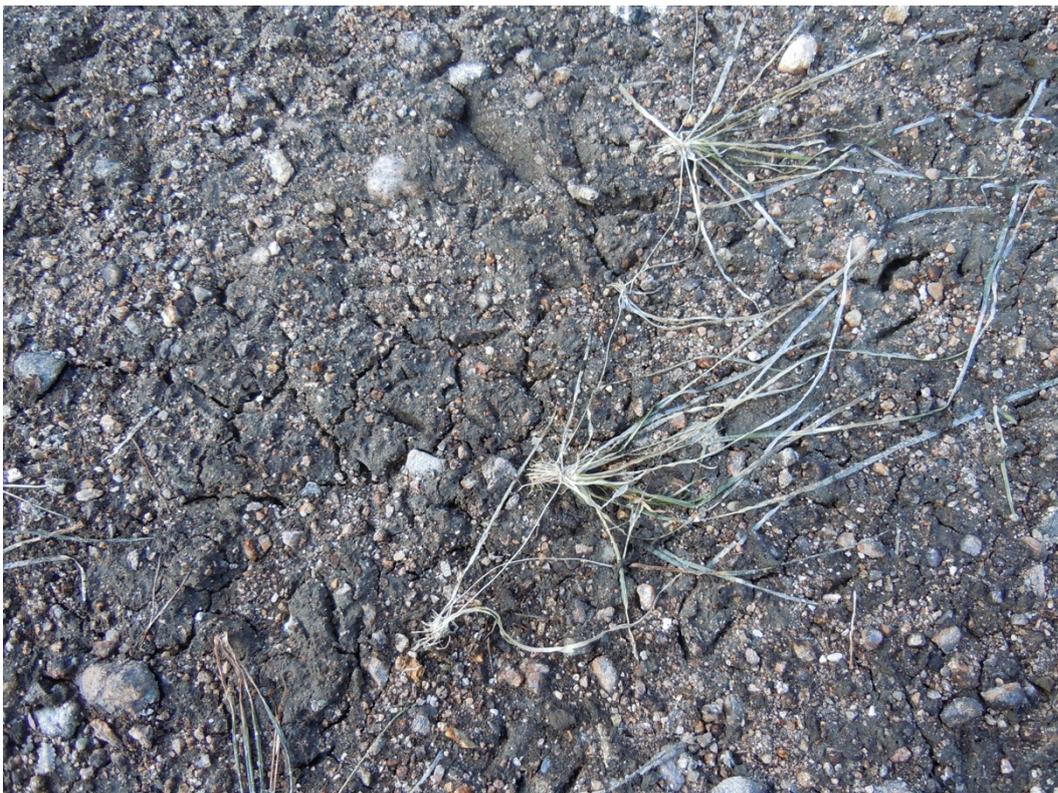
Photo 9. After rinsing the silt-clay layer and exposing the roots, *Luronium* had no chance of surviving. 19.05.2020.

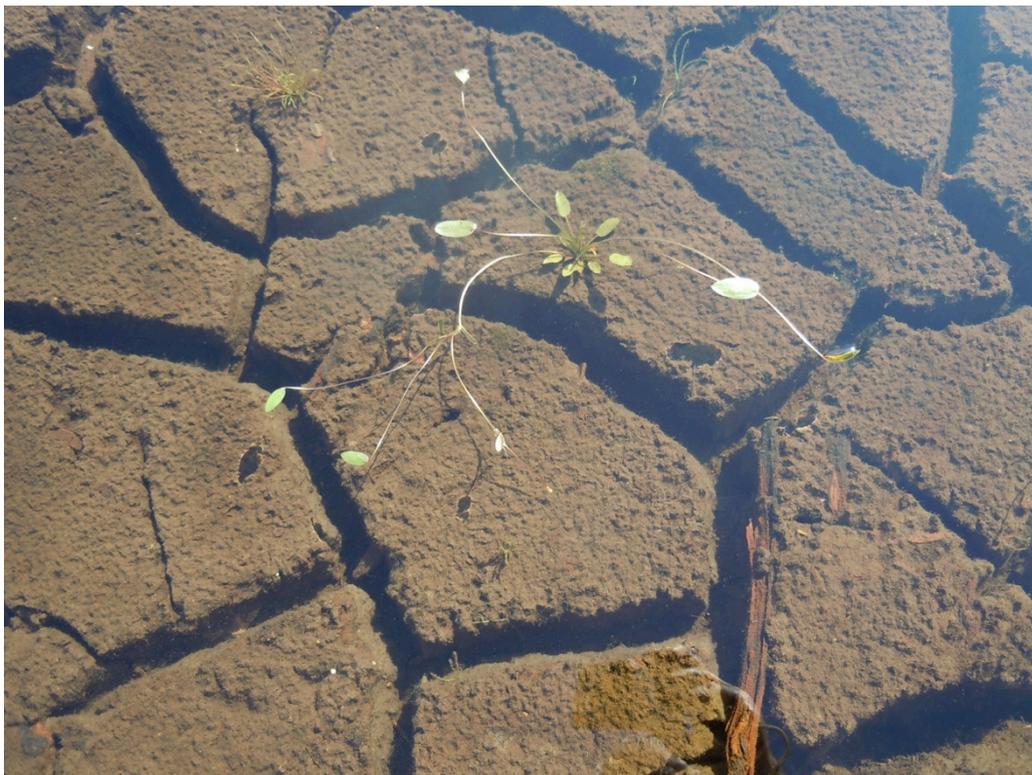
Interesting facts include the survival of plants that germinated from seeds during the summer of 2020 on the then exposed bottom with moist silt at a depth of 4 - 6m. This is a depth that the *Luronium* in Breisjøen did not grow at.

Photo 10. *Luronium natans* which germinated from seeds in summer 2020 on a muddy bottom (5m deep from the maximum water level). These plants survived until the summer of 2021 - on the map 6. marked in pink "C". Shallow flooded in the photo – 08.08.2020.

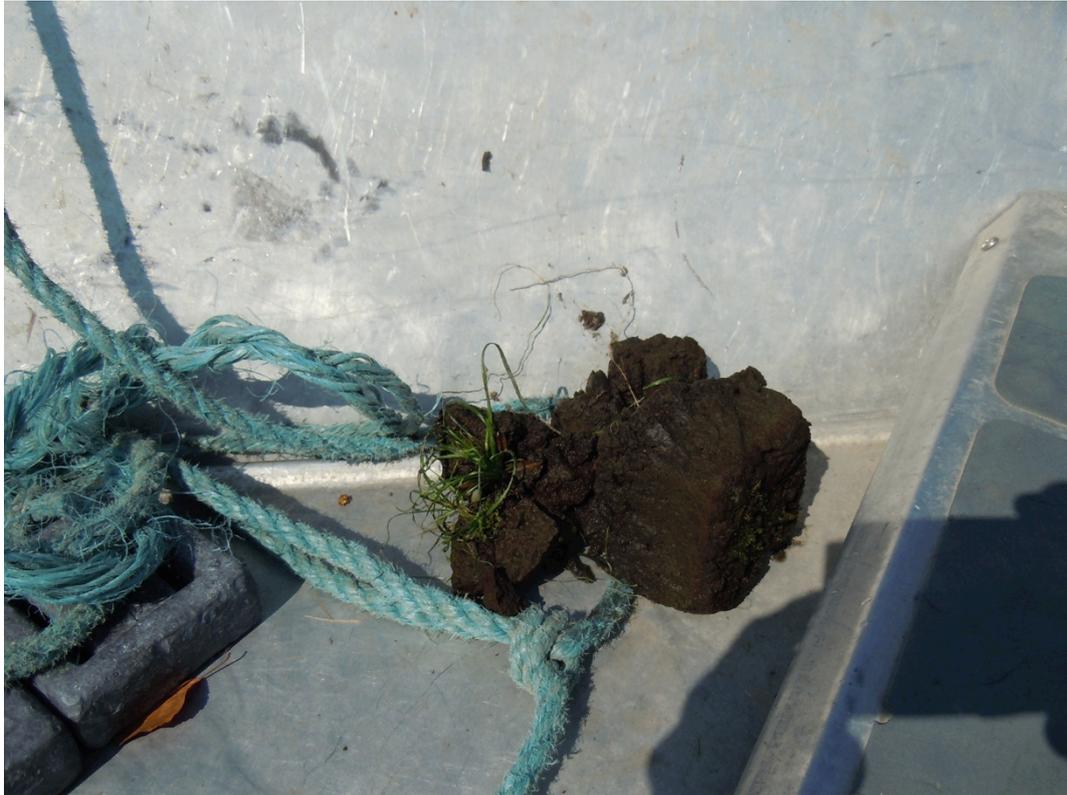
Photo 11. Vegetative form of *Luronium* pulled out from the depth of 5m. 23.07.2021.

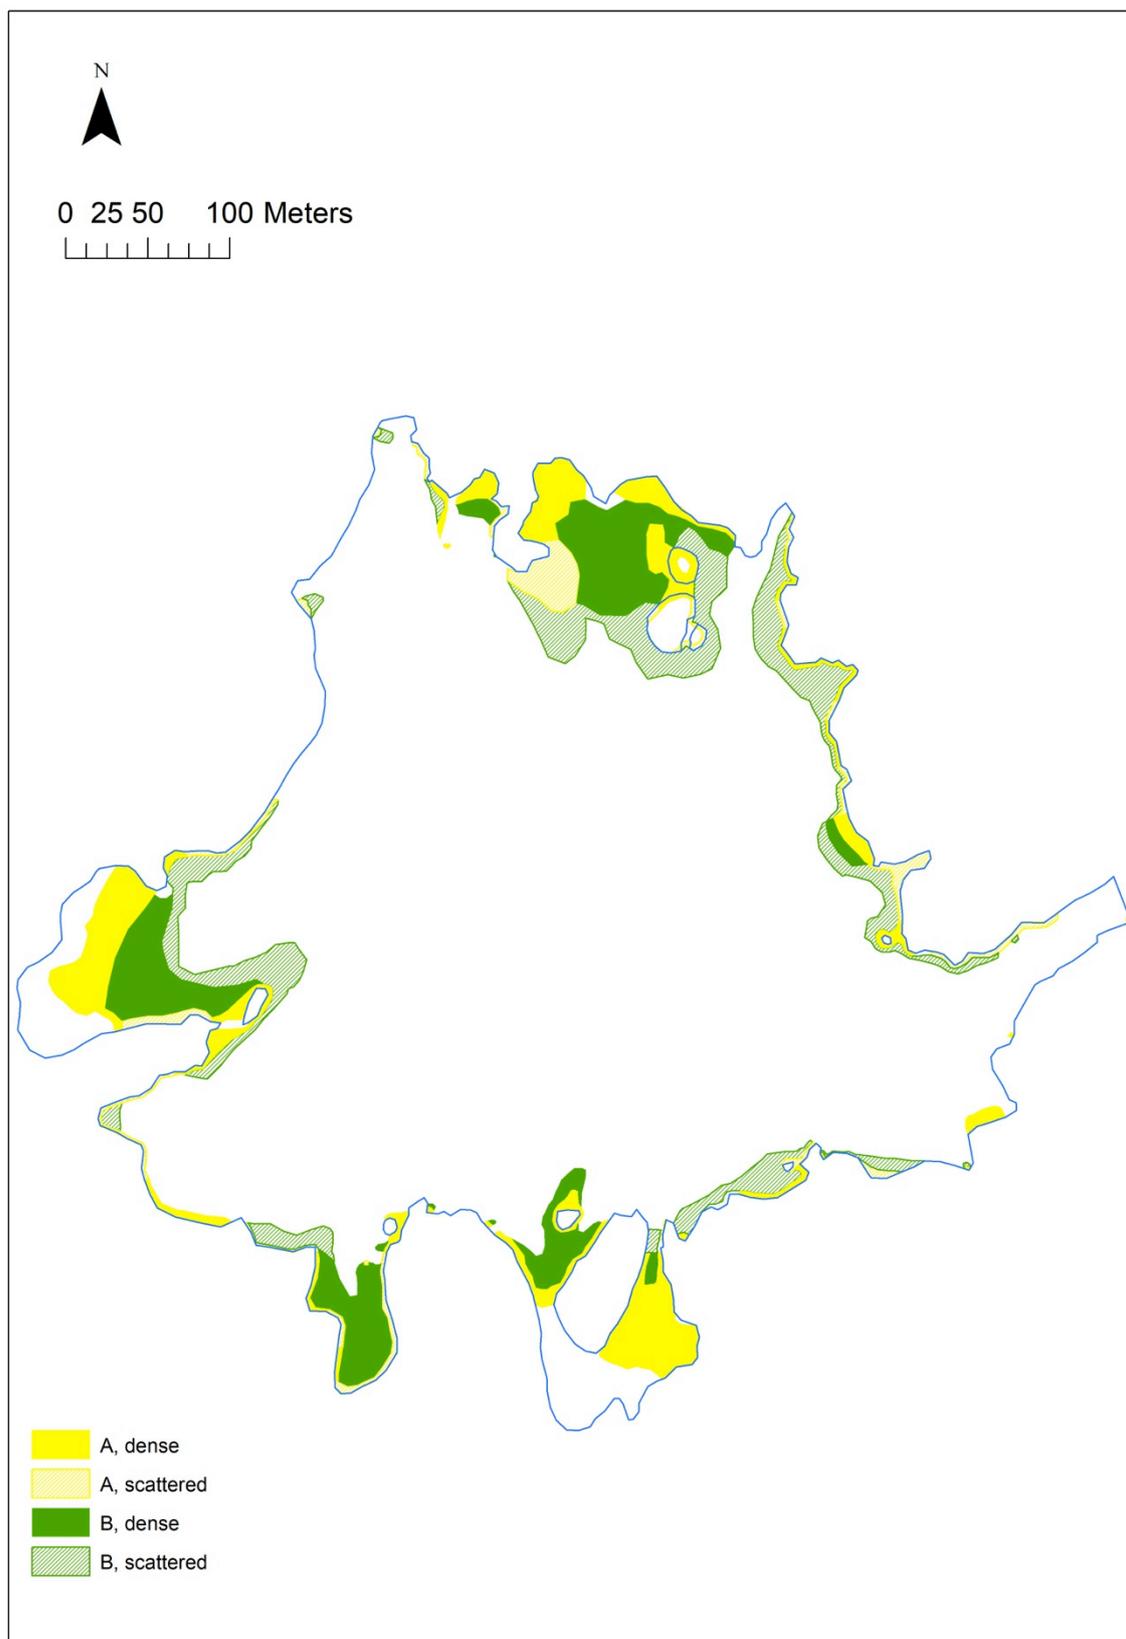
The same method was used to make a map of the *Luronium* population distribution in Breisjøen in 2018, prior to the rebuilding of the Dam. Thus, the comparison of these two maps allows to assess the changes and the effectiveness of the protective measures taken with the *Luronium* population after the lake was emptied during the rebuilding of the dam in 2020

Map 5. Breisjøen. Distribution of the *Luronum natans* population in 2018. Authors: Katarzyna Bociąg & Roman Gramsz.

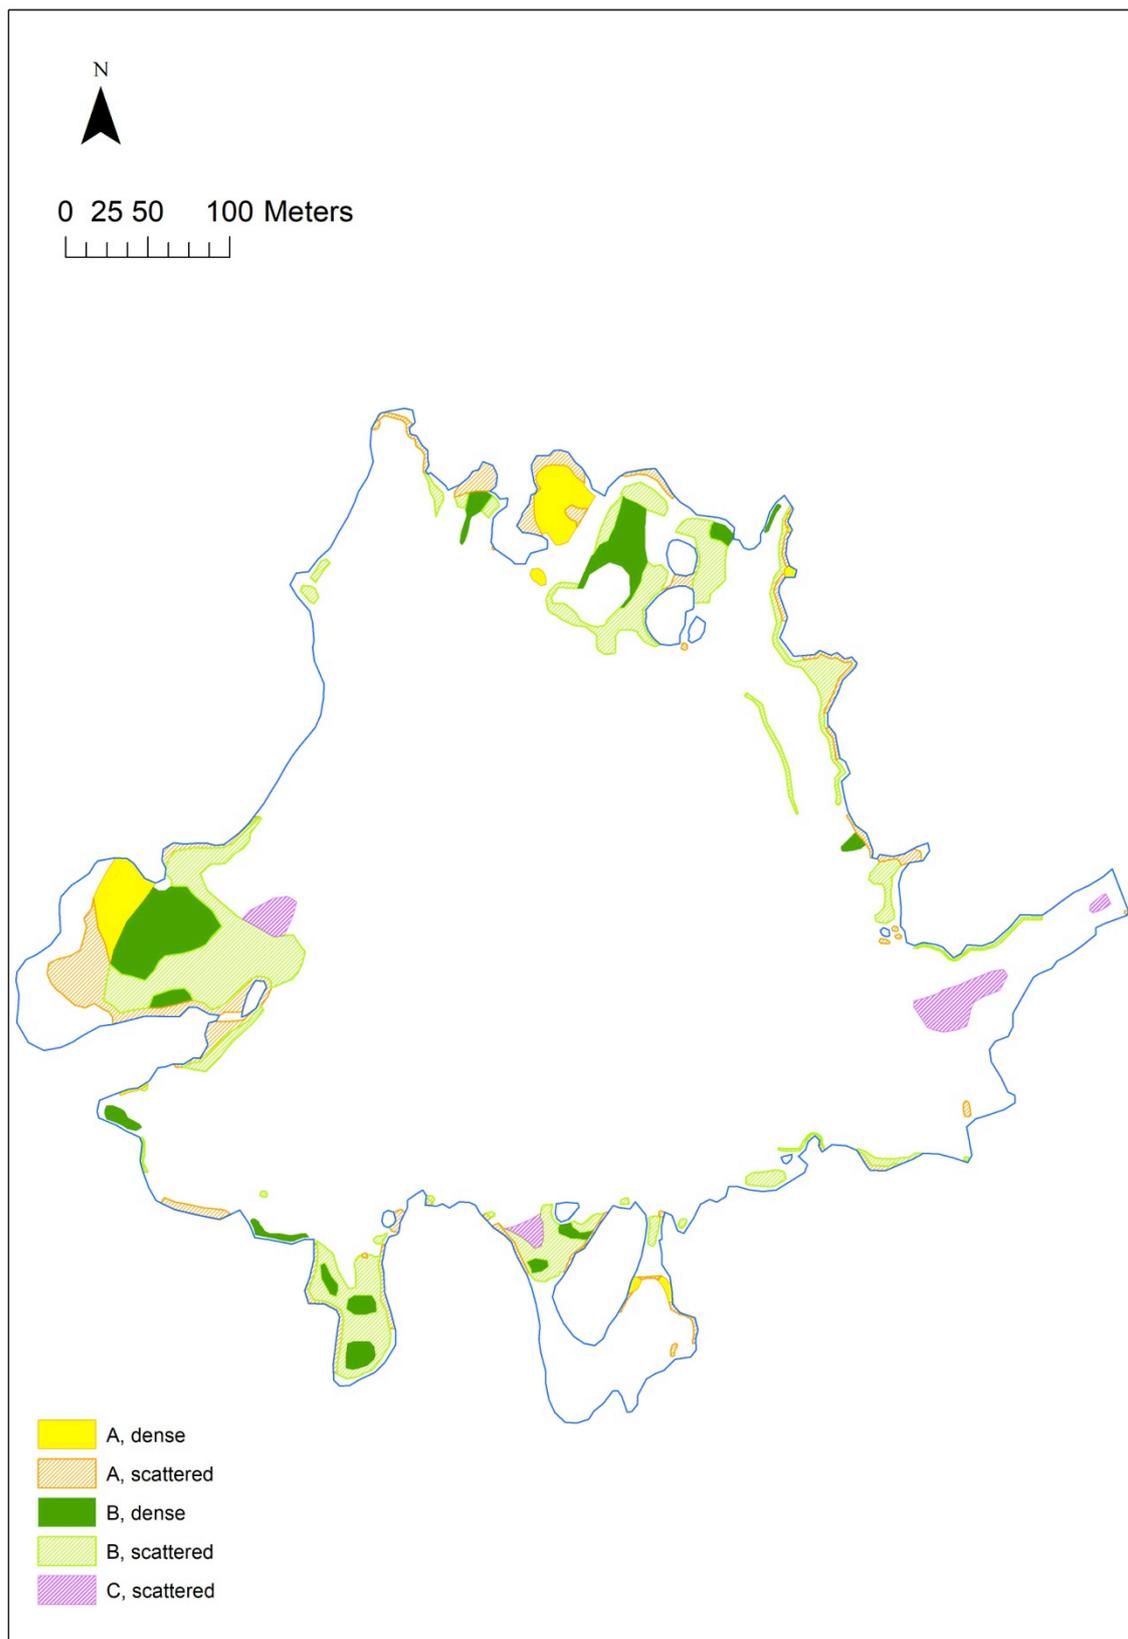
**On Breisjøen, plants survived on 73% of the 2018 area.**

**Thus, the area occupied by the *Luronium natans* population decreased from 37716 m<sup>2</sup> in 2018 to 27746 m<sup>2</sup> in 2021.**

**Plants in the shallow and steep parts of the bottom were the most affected and the best surviving in large bays with a thick layer of silt. Also the areas with plants that survived the drainage of the lake are significantly thinned out. See Table 1.**

Map 6. Breisjøen. Distribution of the *Luronum natans* population in 2021. Authors: Katarzyna Bociąg & Roman Gramsz

- 5. Further monitoring of the population status of *Luronium natans* in Breisjøen is highly recommended. Significant habitat change caused by clay and silt erosion may result in population decline rather than its regeneration in the coming years.**
